**John P. Broomfield
Broomfield Consultants**

Consulting Corrosion Engineers

Broomfield Consultants Case Histories Page 1 of 4

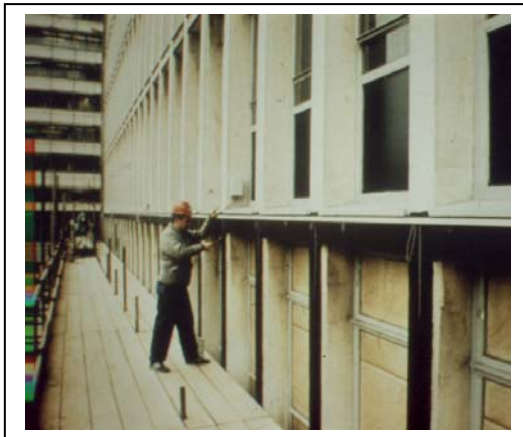
Figure 1a Conductive coating on front face

Case 1 – Structure and Location – Office Building Southend-on-Sea, UK
Cause of corrosion – Calcium Chloride (CaCl_2) set accelerant cast in during construction
Cathodic Protection Description – Conductive organic solvent based coating with protective/decorative top coat
Parties and dates – UK Government building, Taywood Engineering design and install, 1986
Comments – One of the first full scale cathodic protection installations in the UK

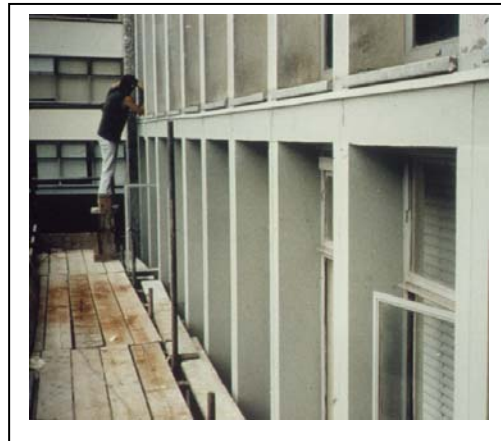
Figure 1b Cosmetic overcoat applied

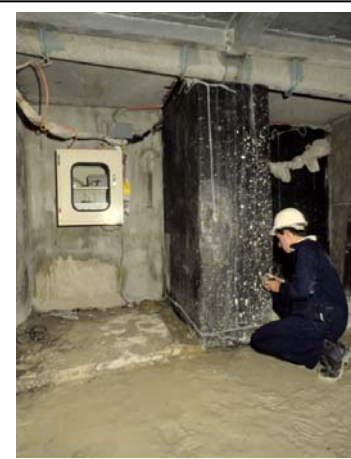
Case 2 – Structure and location – Concrete silo, Western Australia
Cause of Corrosion – salt water ingress
Cathodic Protection Description – Conductive organic coating (chlorinated rubber) used for easy maintenance and repair in industrial environment.
Parties and dates – Designed and installed by Taywood Engineering (Australia) 1987.
Comments – one of the first impressed current cathodic protection installations in Australia

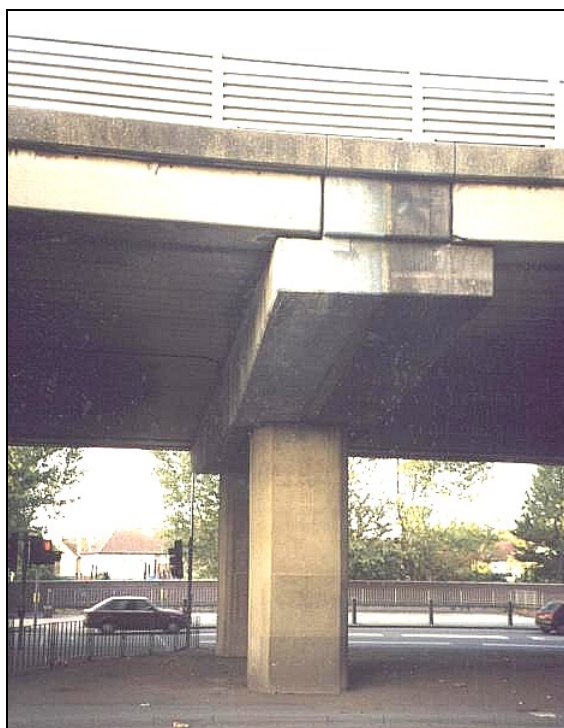
Case 4 – Structure and Location – M4
Elevated section cathodic protection
trials, London
Cause of Corrosion – deicing salts
from winter salting
Cathodic protection description –
cathodic protection trials, solvent and
water based conductive coating anodes,
thermal sprayed zinc and titanium,
mixed metal oxide coated titanium
mesh and conductive mortar.
Parties and dates – Specification John
Broomfield for WSP, (Highways
Agency term consultant), detailed
design and installation Makers UK,
Installed 1996
Comments – covers traffic control

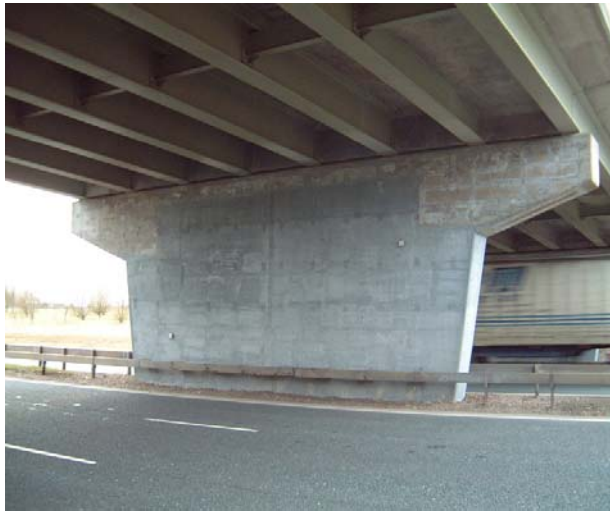
Case 5 – Structure and location – Motorway interchange, M6 Cumbria
Cause of Corrosion – Deicing salt leakage through deck joints
Cathodic Protection Description – Arc sprayed zinc anode with probe anodes on cantilevered ends and sheer walls between beams
Parties and dates – Owner, highways agency, consultant AmeyMouchel, outline design and specification John Broomfield, Detailed design and installation Makers UK, installed 2002.
Comments – First major use of arc sprayed zinc system in UK

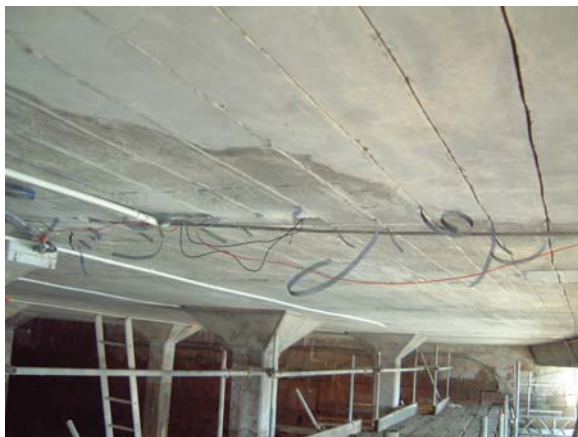
Case 6 – Structure and location – New North Quay Jersey, Channel Islands
Cause of Corrosion – Marine salt
Cathodic Protection Description – Mixed metal oxide coated titanium expanded mesh ribbon
Parties and dates – Consultant Jersey Public Services Department, CP Specification, John Broomfield, Installed Brookes (Northern).
Comments – Applied to columns and beams and some soffit areas

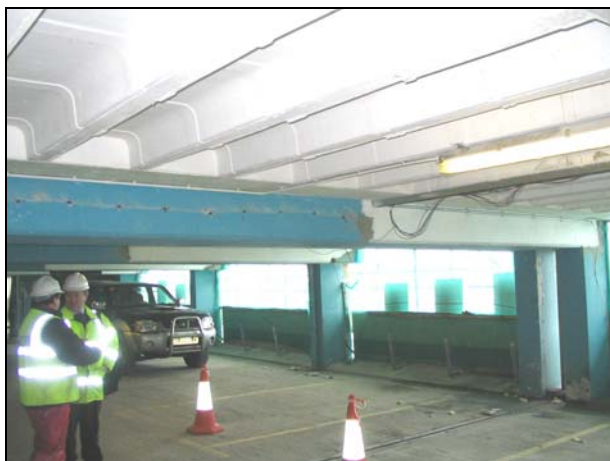
Case 7 – Structure and location – Pier Road Multistorey cat park, St Hellier, Jersey
Cause of Corrosion – Sea salt spray
Cathodic Protection Description – Probe anode installations to selected beams and columns
Parties and dates – Consultant Jersey Public Services Department, CP Specification, John Broomfield, Installed Concrete Repairs Ltd, installed 2005
Comments – selective installation with protective coatings elsewhere provides cost effective corrosion

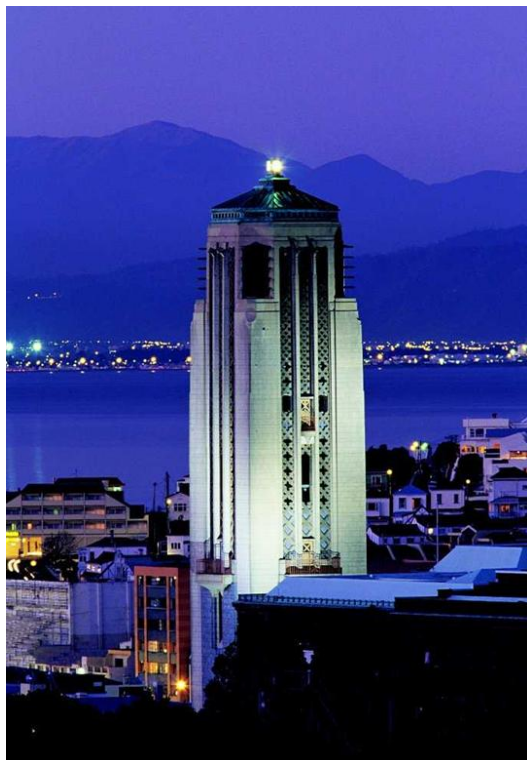
Case 9 – Structure and location – National War Memorial, Wellington New Zealand

Cause of Corrosion – Sea Salt spray through openings in carillon tower

Cathodic Protection Description – Local application of probe anodes to corroding areas.
